EFFECTIVENESS OF TYRE CHIPS AS
ALTERNATIVE MATERIAL IN INCLINED
GABION WALL TO MITIGATE SLOPE
FAILURE

B. ENG(HONS.) CIVIL ENGINEERING

UNIVERSITI MALAYSIA PAHANG

Thesis submitted in fulfillment of the requirements
for the award of the
Bachelor Degree in Civil Engineering

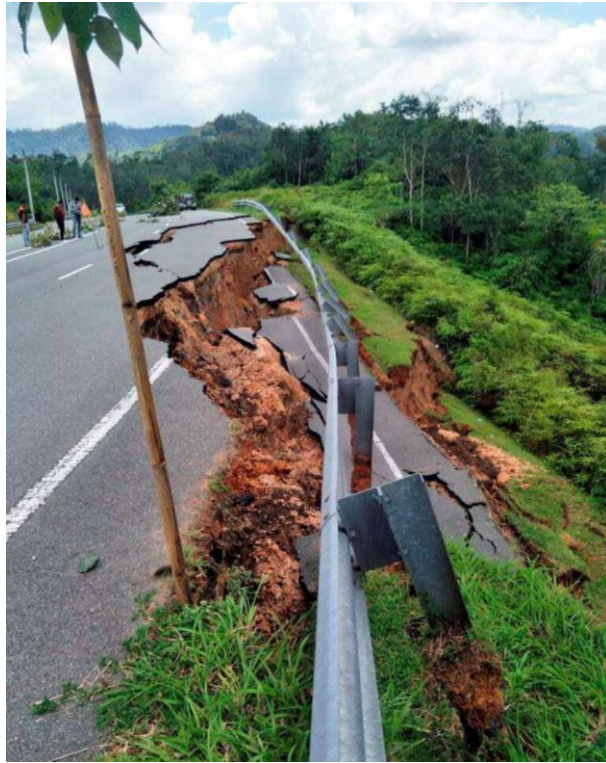
Figure 1.1 Landslide at the Cameron Highlands-Sungai Koyan road
Source: m.thestar.com.my/

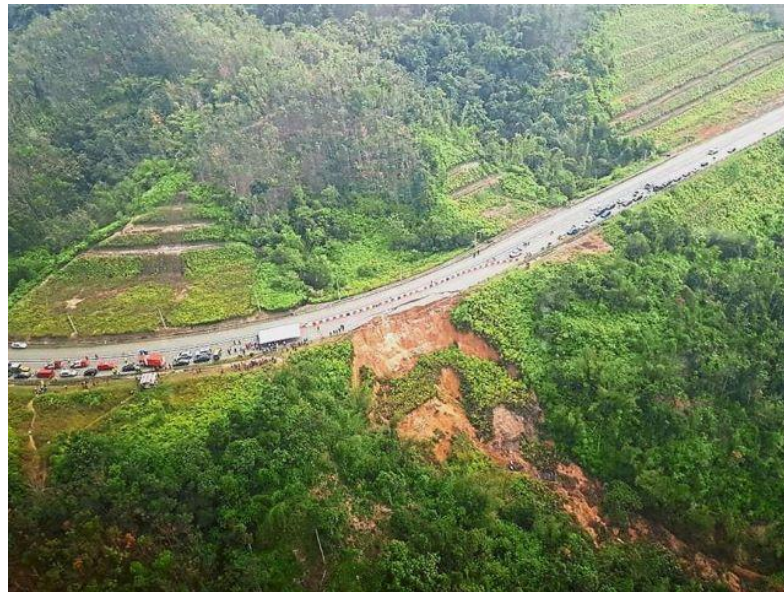
Figure 1.2 Landslide at the Cameron Highlands-Sungai Koyan road
Source: www.nst.com.my
